Radke photos of 10/27/14

Critical area alterations (excavations) were first observed on 10/20/14

Radke stream alterations noted on 10/20/14

Photos taken on 10/27/14

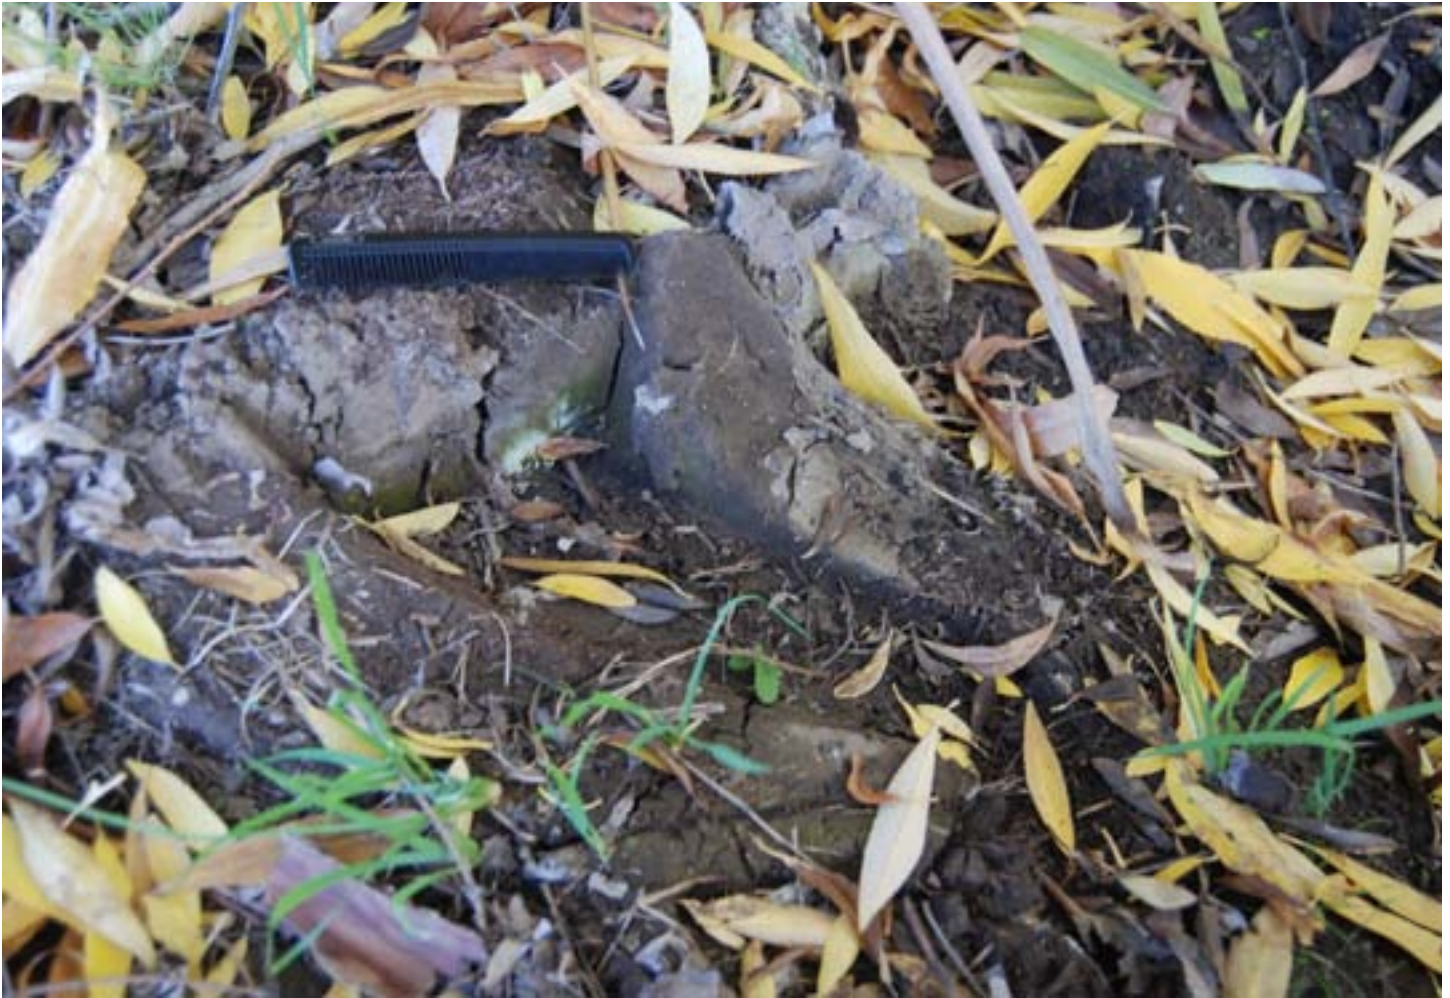
Tire marks in the mud immediately north of the stream at about the mid-portion of the Radke property. There were tire tracks only on land to the north of Shaw Creek. Dense vegetation on the south side of the stream did not show any evidence of tire marks or the presence of the excavator on land to the south.

Matthew Seaman place his pocket comb next to the tire tracks to show the size of the mark in the mud.

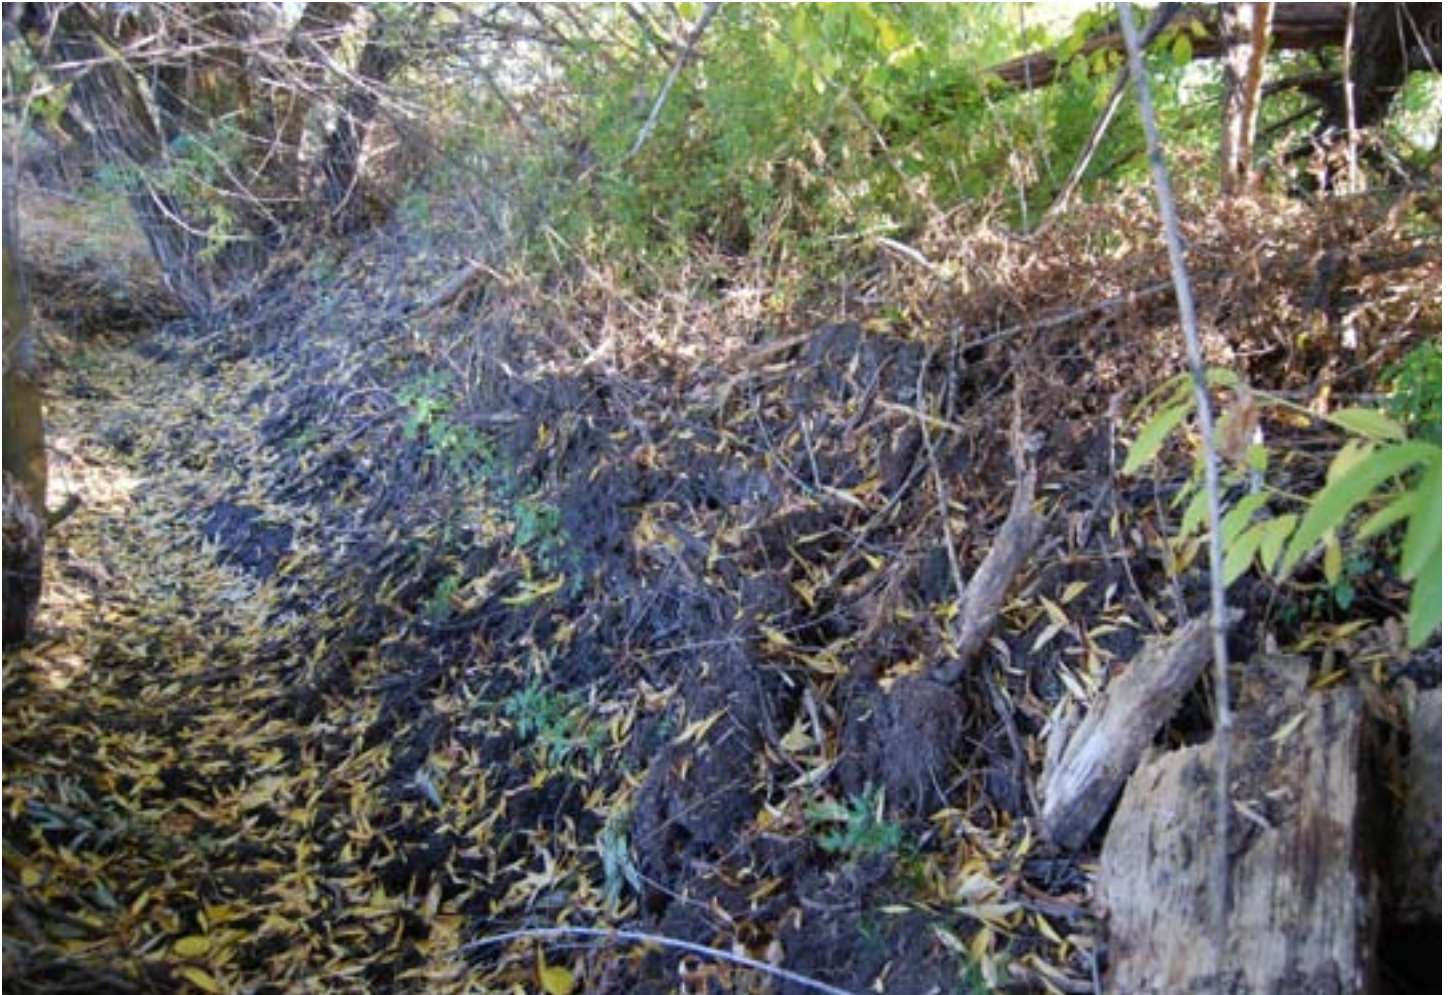
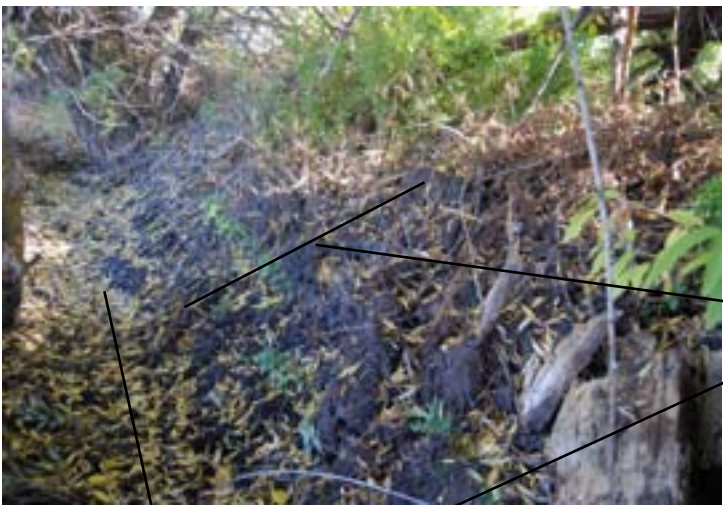
Fill material has been dredged from the base of the stream and placed upon the vegetation along the high water mark of the south bank of the stream.

Centerthread of the Shaw Creek watercourse

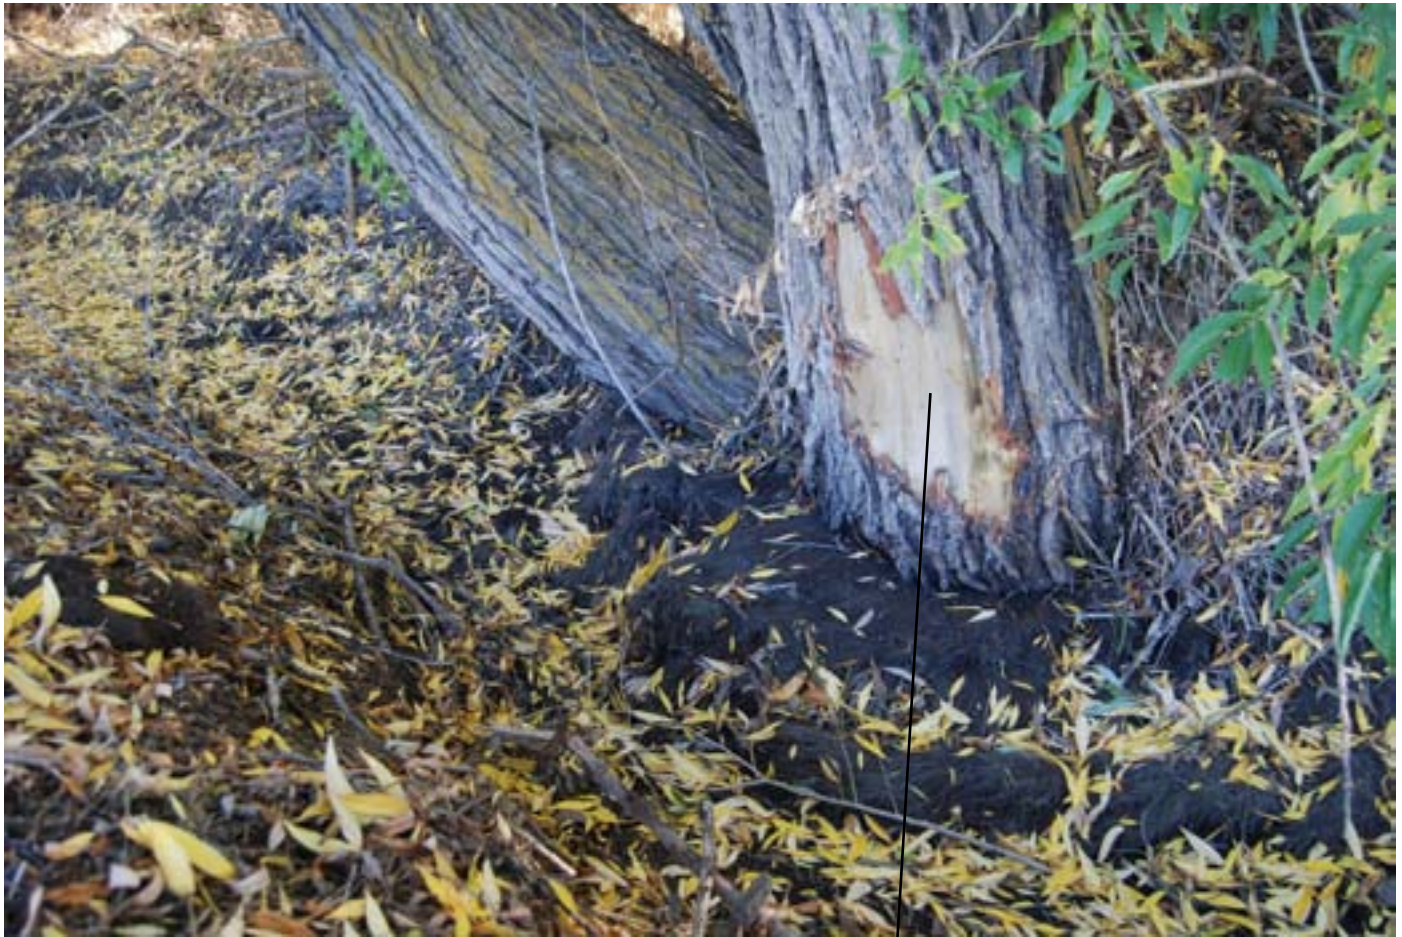
Denuded bark on tree trunk caused by the excavator bucked

Centerline of the watercourse. The channel has been deepened. Previously wetland vegetation has been removed. Previously there was an abundance of grass and irises. Now there is only mud within the watercourse. Shaw Creek is an F-stream with perennial flows of water. For the only time in the last 25 years, flows of water have stopped. Water flows onto the Bainter land. Water does not flow through the Bainter land. Here, on the Radke parcel, there is no water within the watercourse of Shaw Creek. There is only mud. Prior to the dewatering of Shaw Creek, there were pools containing fish along the course of Shaw Creek.

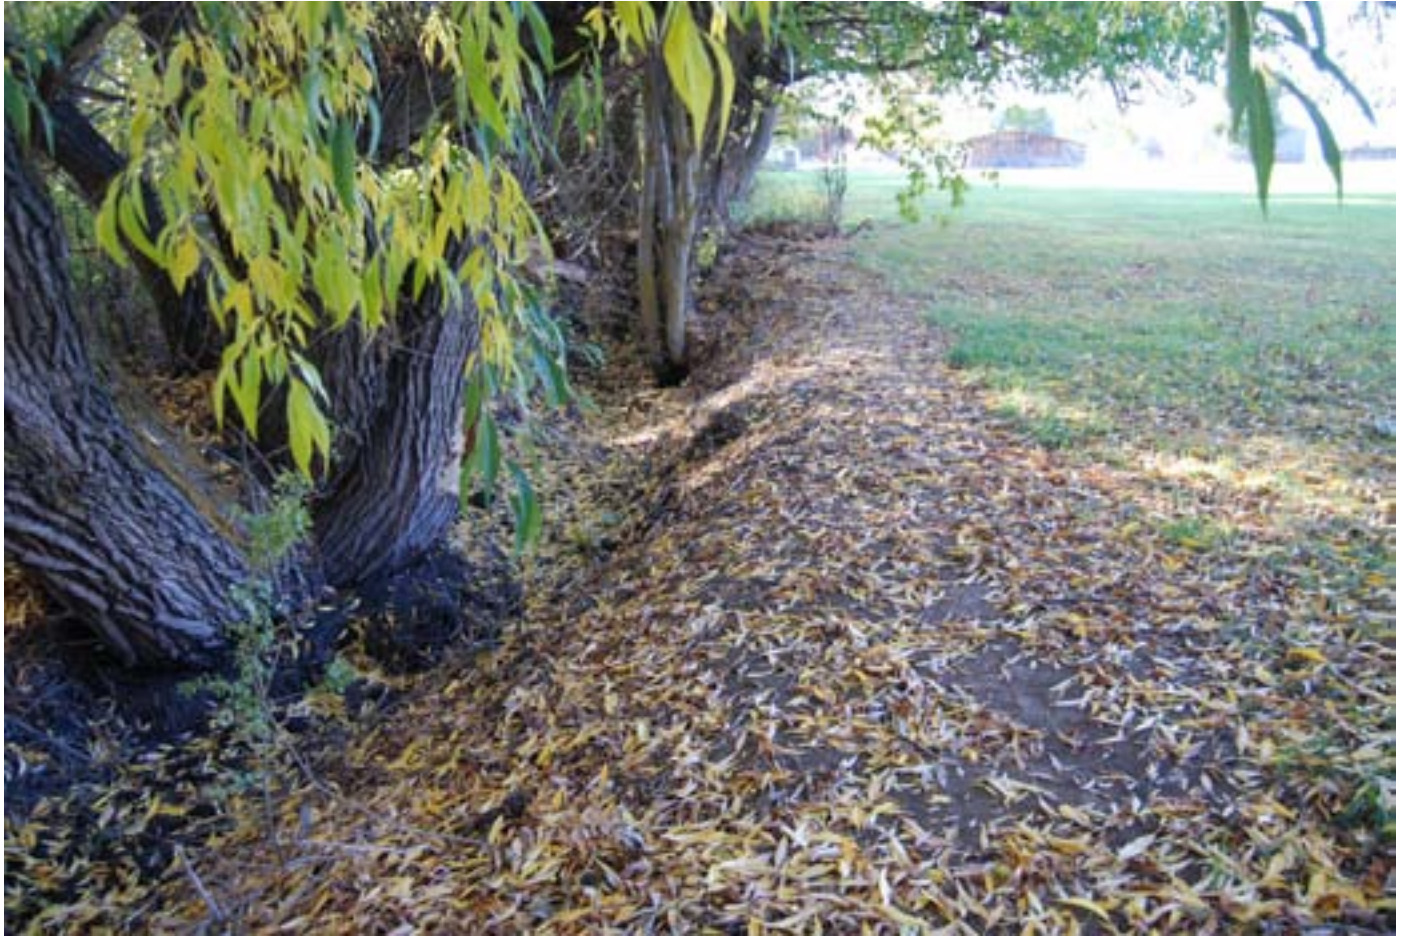
The north bank of Shaw Creek. There is a lack of native vegetation up to the high water mark of the stream. Mr. Radke repeatedly mows up to the high water mark of the stream. The barren soil is beginning to be covered with falling leaves on Sept 27, 2014. This barren soil indicates the use of herbicide within the riparian zone of Shaw Creek

Shaw Creek on the east side of the Radke parcel. In this location, fish pools have been destroyed. There are no pools, no fish and no vegetation in the central portion of the stream. There is only mud, now being covered by leaves.

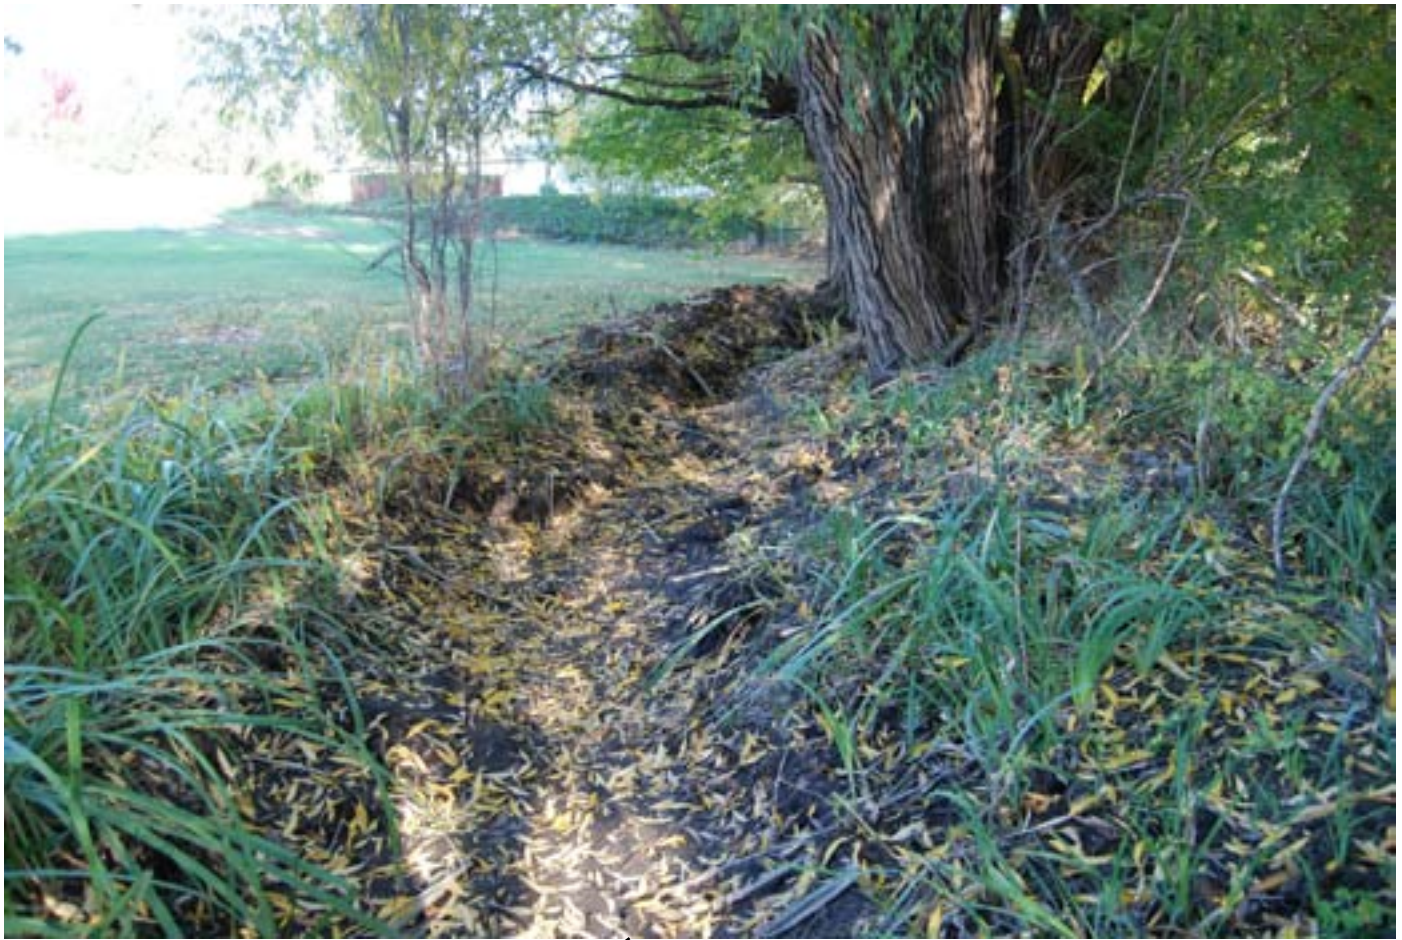
Watercourse - now with an excavated area of mud

Wetland vegetaion along the north bank of the stream on the Radke side.

In this area, mud is covering some of the wetland vegetation (on the south side of the stream). Some vegetation has recovered and is standing upright.

Radke portion of Shaw Creek. This is a portion of the stream near the east property line. For the first time in 25 years, there are no flows of water within the stream. The date of the photo is 10/27/14. Excavated mud has been piled on the north side of the stream. In this location there were pools of water containing perennial populations of fish. The pools have been destroyed. The fish are gone.

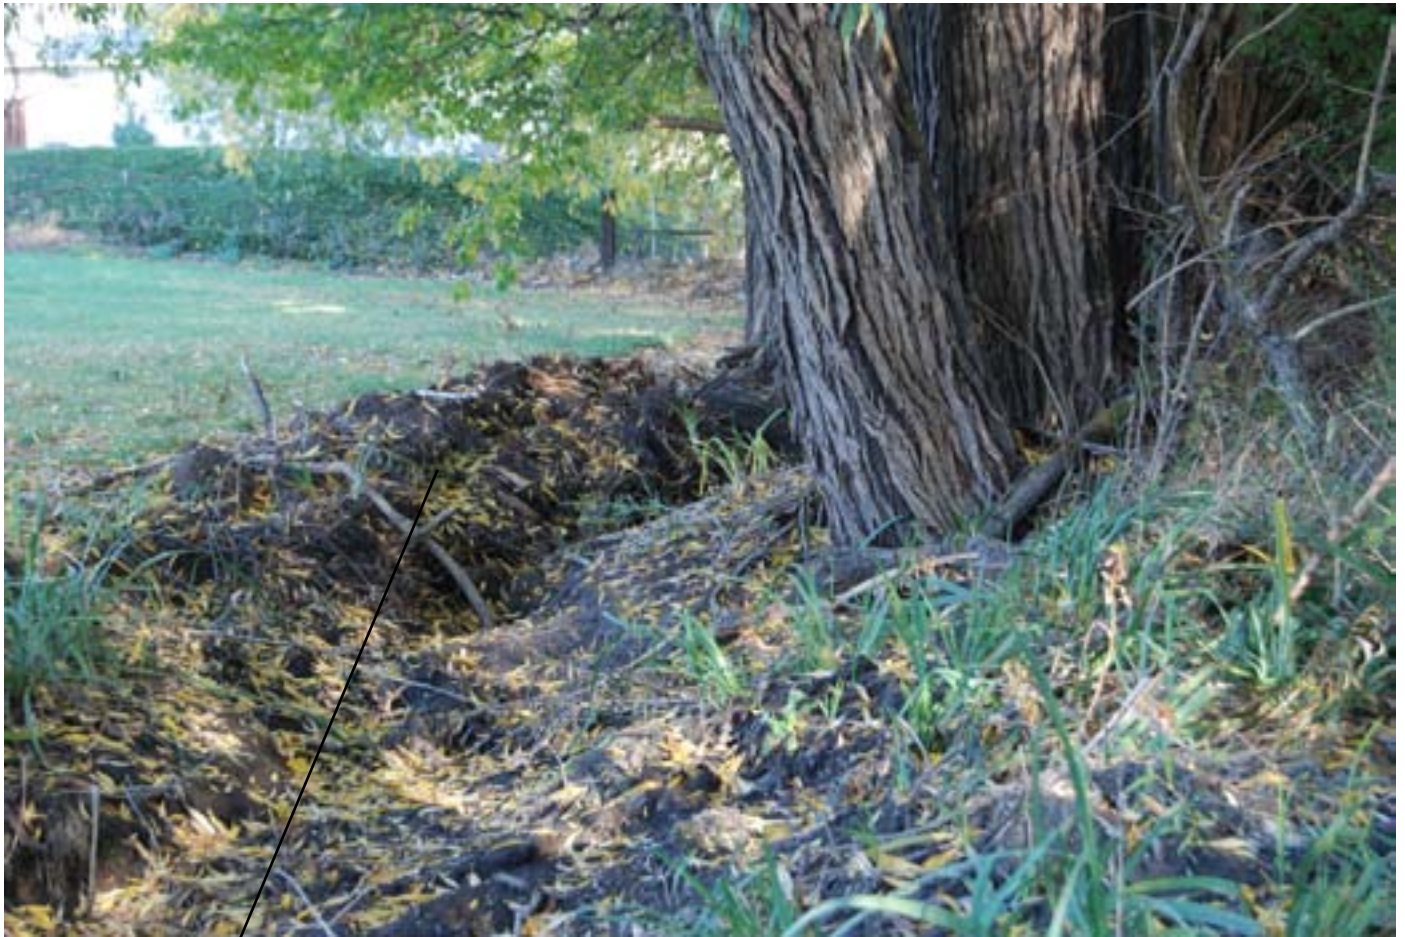
Piles of mud along the north bank of the stream.

Wetland vegetation partially covered with excavated mud from the stream bed

Mud within the base of the stream. There are no pools and none of a natural vegetation

Radke's portion of Shaw Creek. Wetland vegetation is on the north side of the stream (Radke's side) The white and gray mud on the south bank is all excavated material from the bottom of the stream. In this location is appeared that the watercourse was deepened by about 2 feet. On the left side of the photo is a depression where pools have been excavated. There are no pools and no fish.

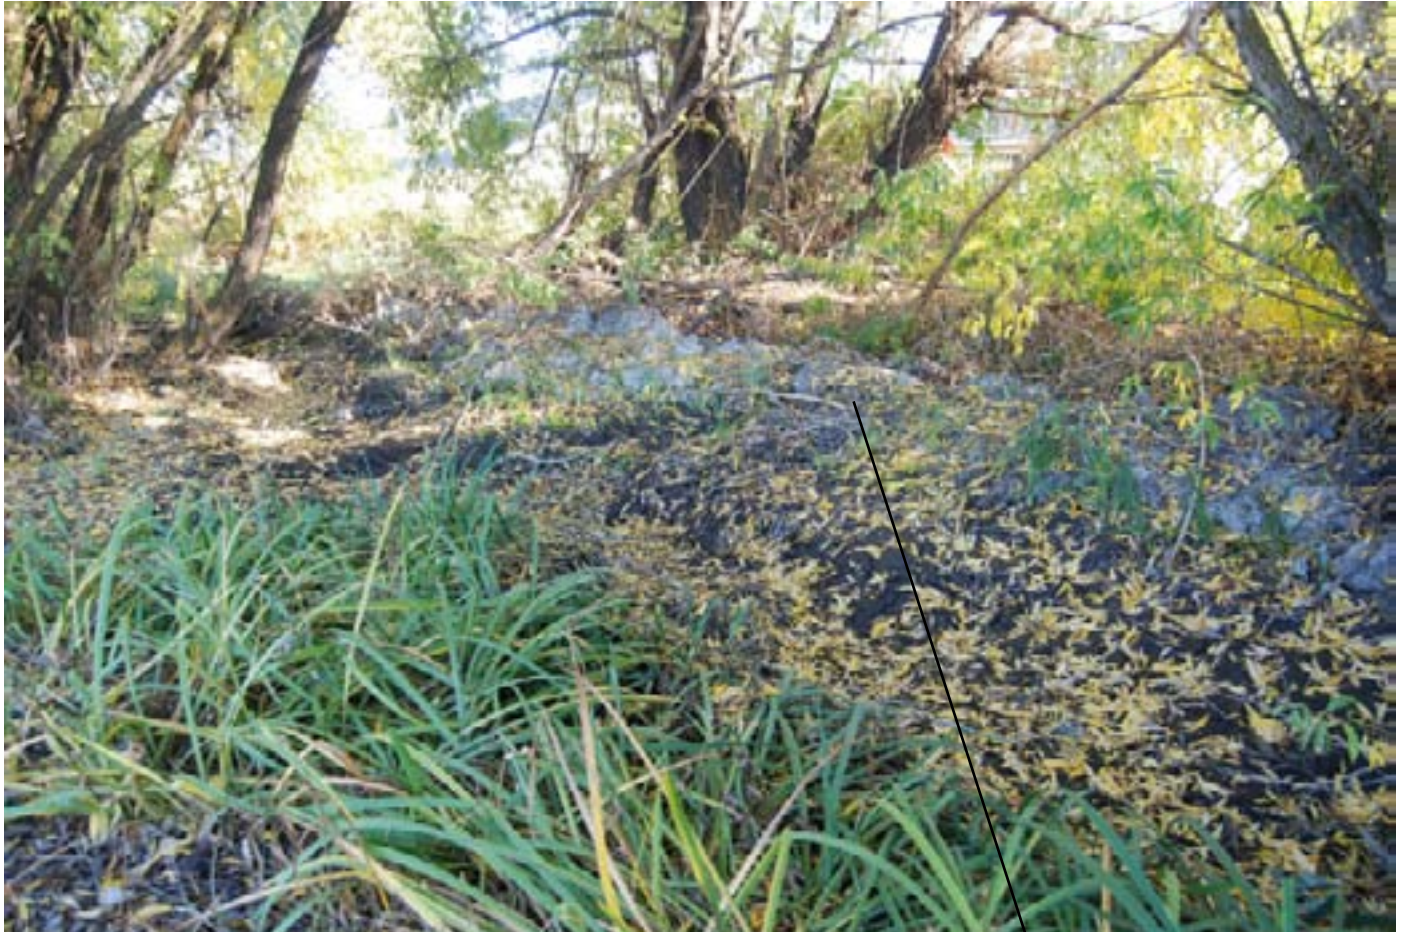
Wetland vegetation of the north bank of the stream

White and gray mud deposited on the south side of the stream

Photo taken along the south bank of Shaw Creek. In this photo a tree with the entire root system has been cast along the south bank of the stream.

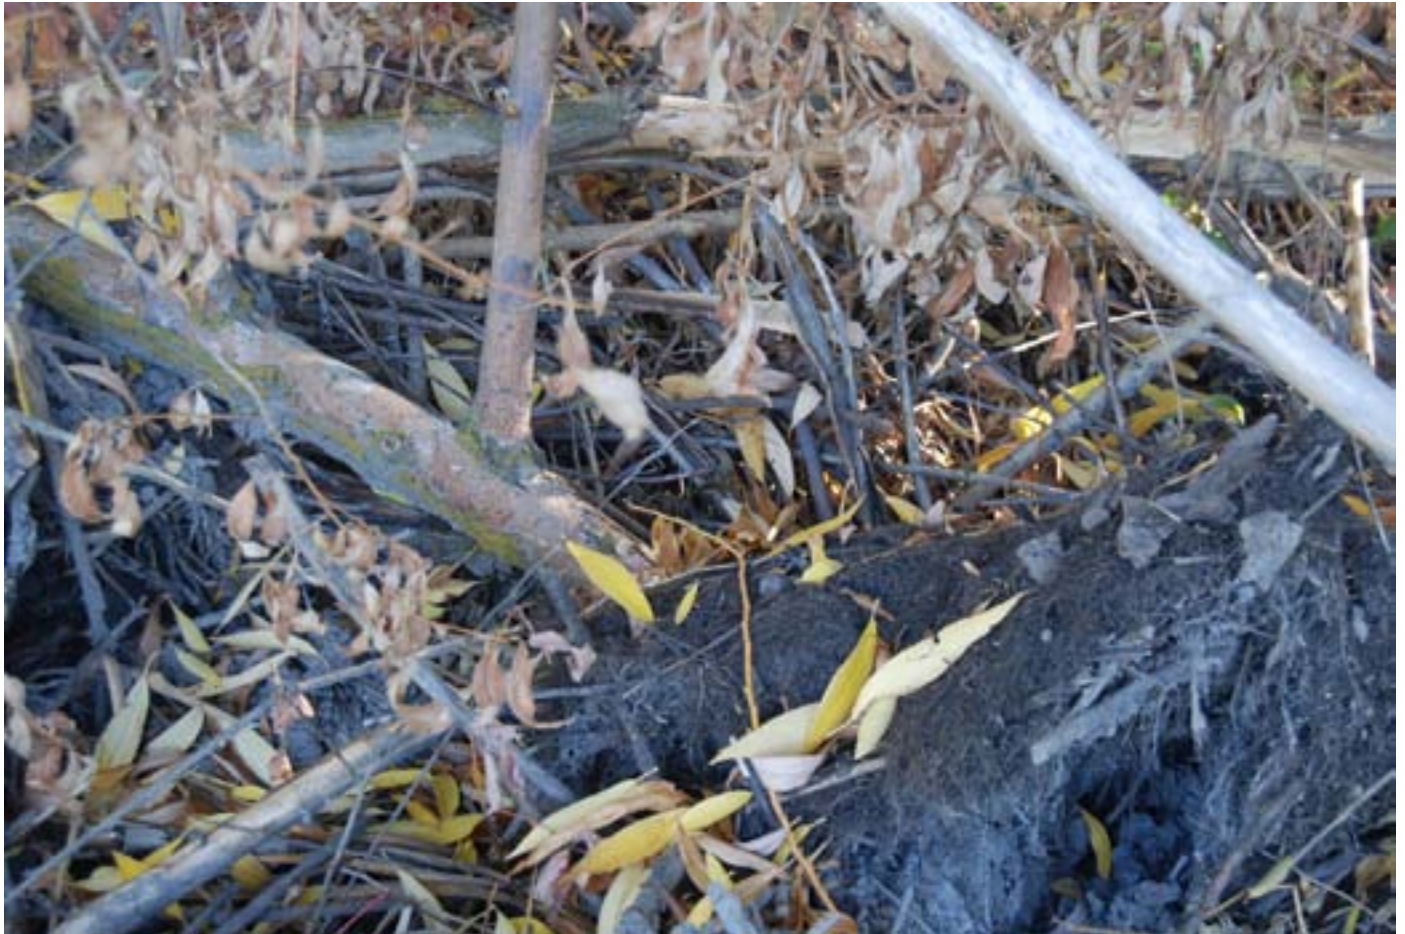
Shaw Creek - October 27, 2014. This is the south bank of the stream. Mud, trees and branches have been piled to the south of the watercourse.

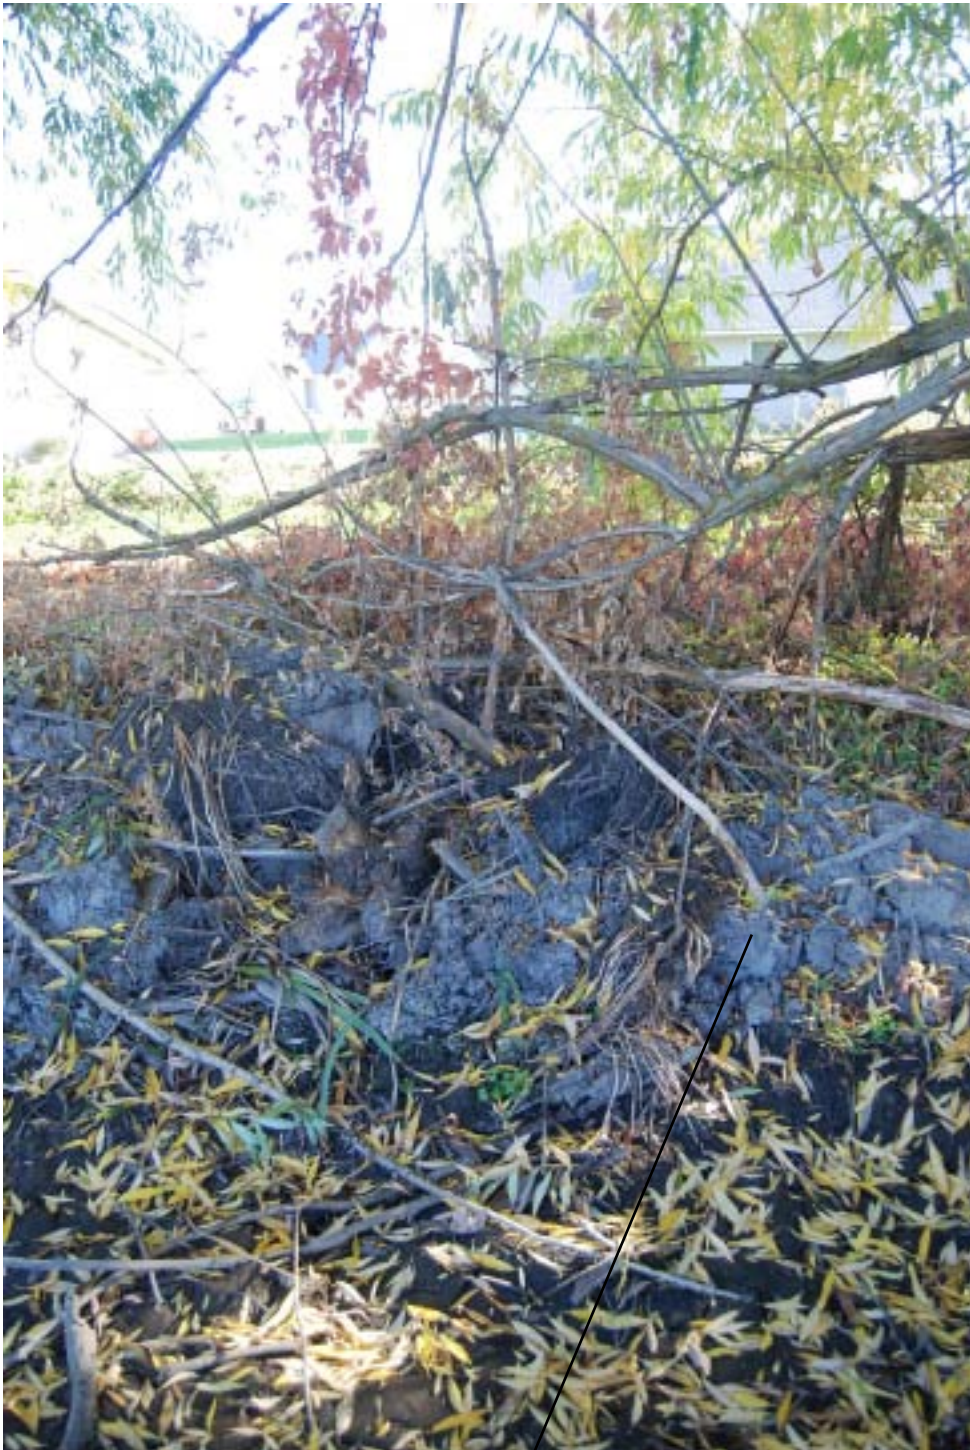
Centerline of the stream - now devoid of water

Excavated mud

Directly over Shaw Creek - The excavator has broken branches and denude the branch (taking bark off the branch) Photo from 10/27/14.

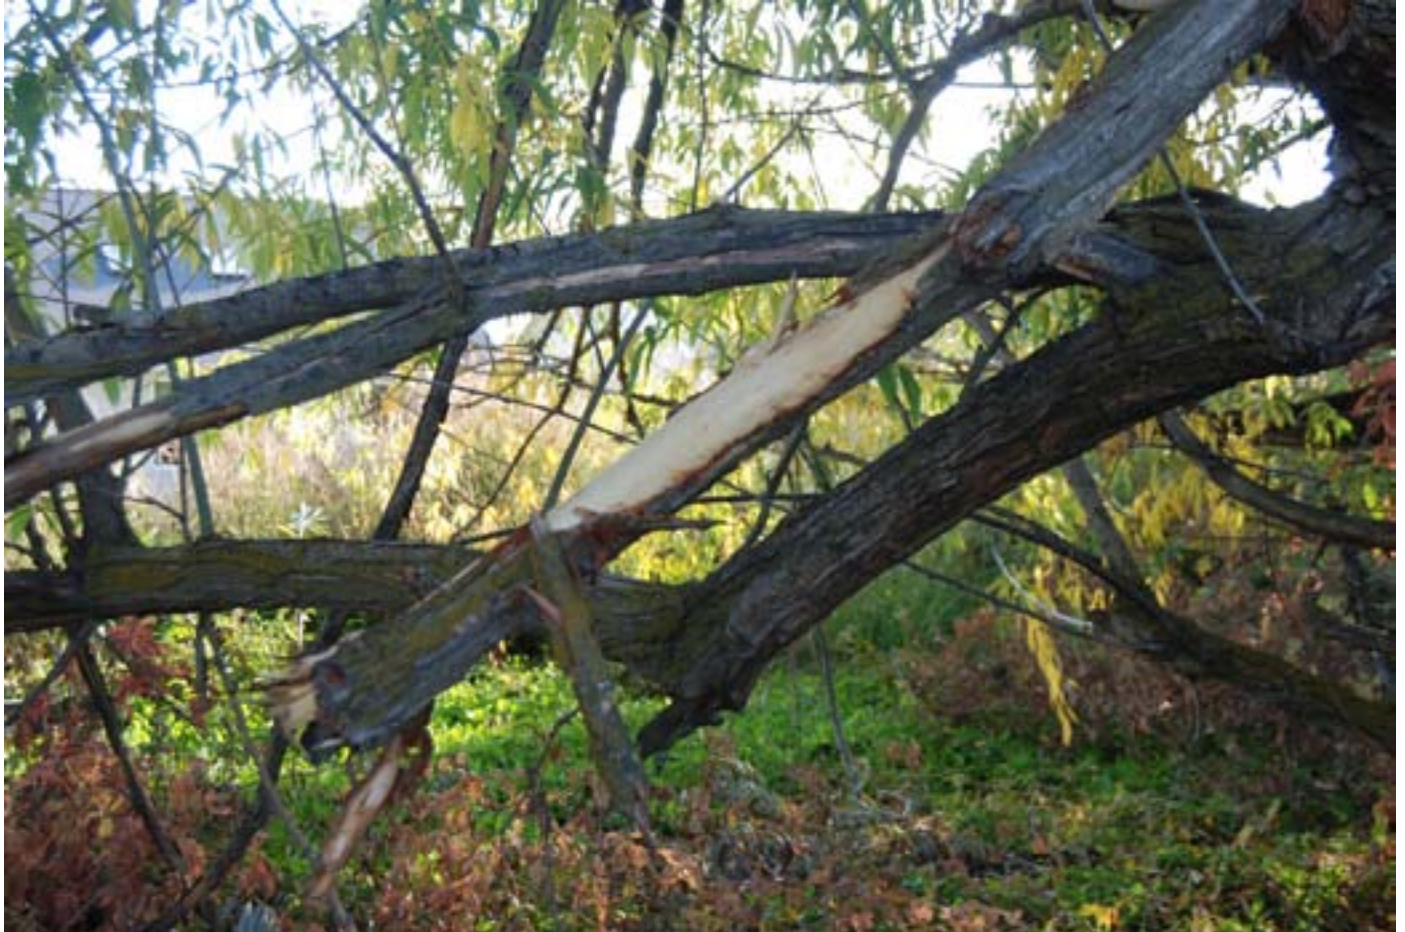
Pile of mud, now drying, next to Shaw Creek along the Radke portion of the stream. The pocket comb was placed on site by photographer to show the perspective. A large excavator deposited the pile of mud.

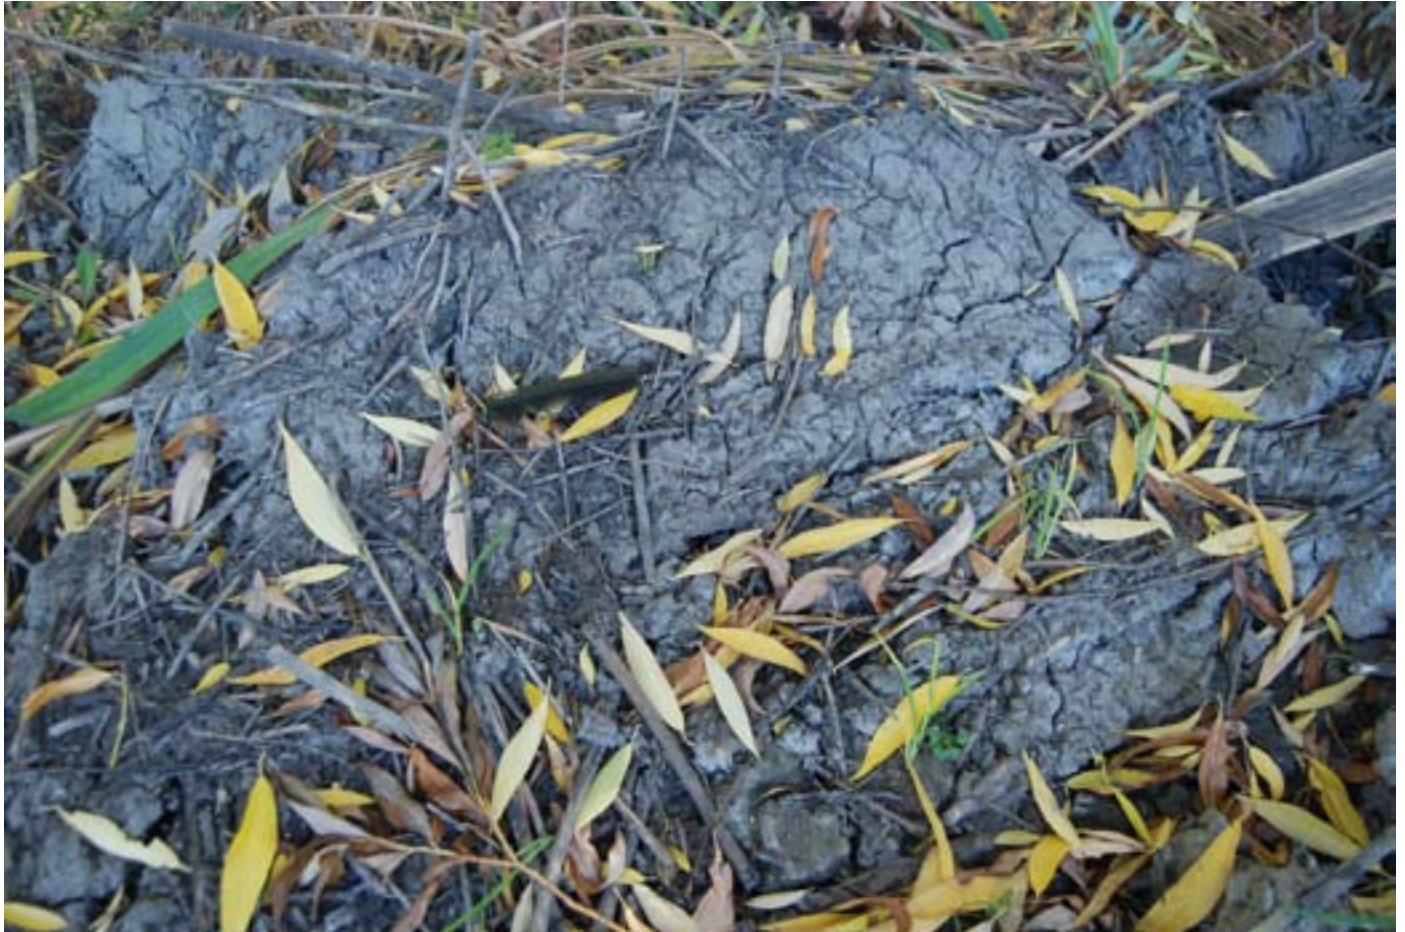
Shaw Creek - watercourse along the Radke portion of the stream

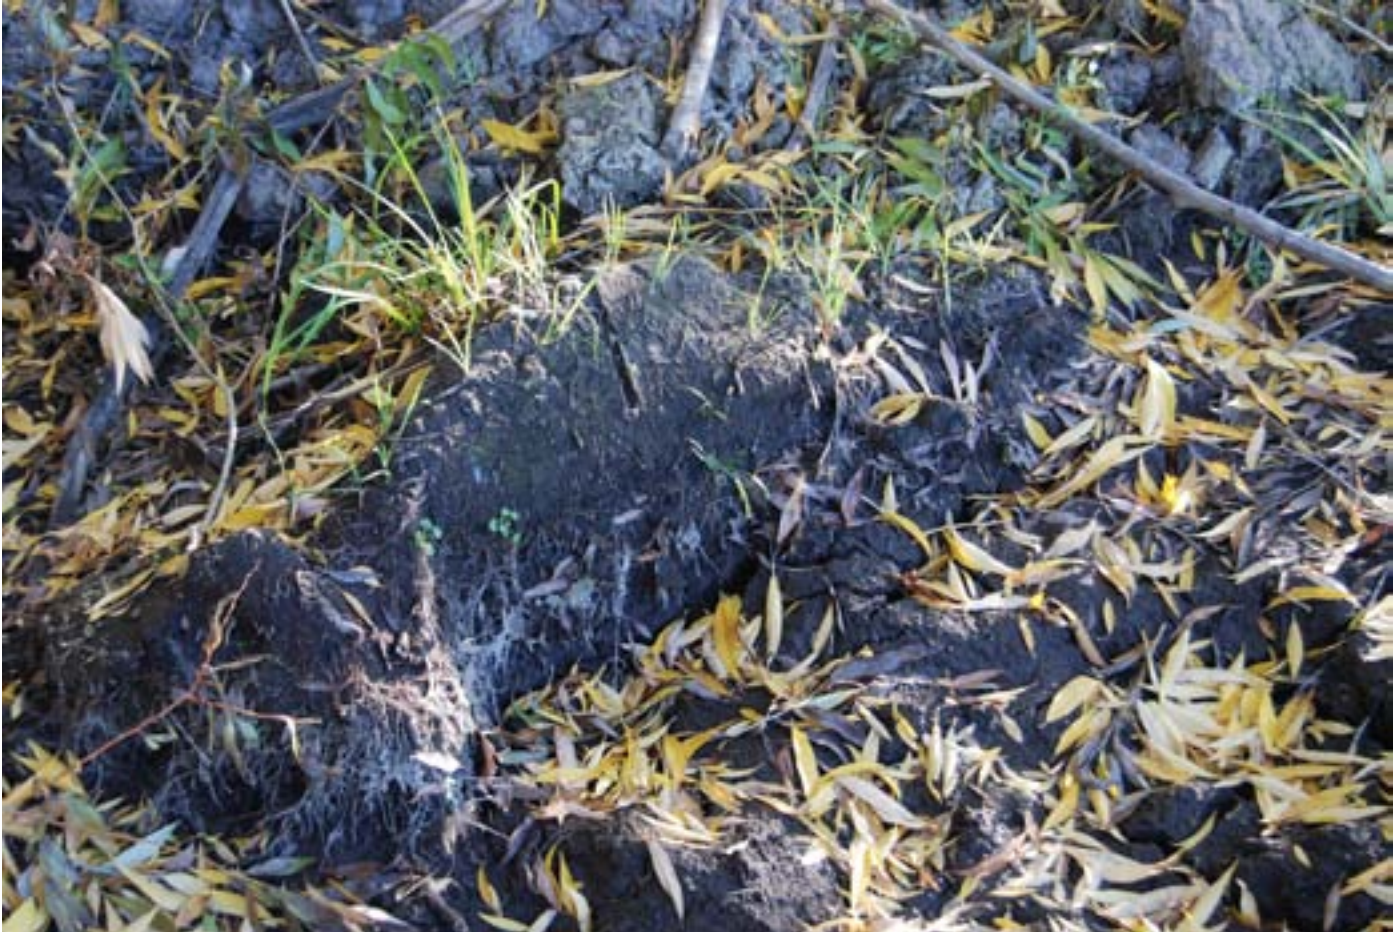
October 27, 2014 - an excavator buck has pushed up the soil

Shaw Creek - directly over the stream. The excavator has significantly destroyed this tree. October 27, 2014.
